DOT/FAA/AR-02/117

Crack Growth-Based Predictive
Methodologies for the
Maintenance of Structural Integrity
of Repaired and Nonrepaired
Aging Engine Stationary
Components

January 2003

Final Report

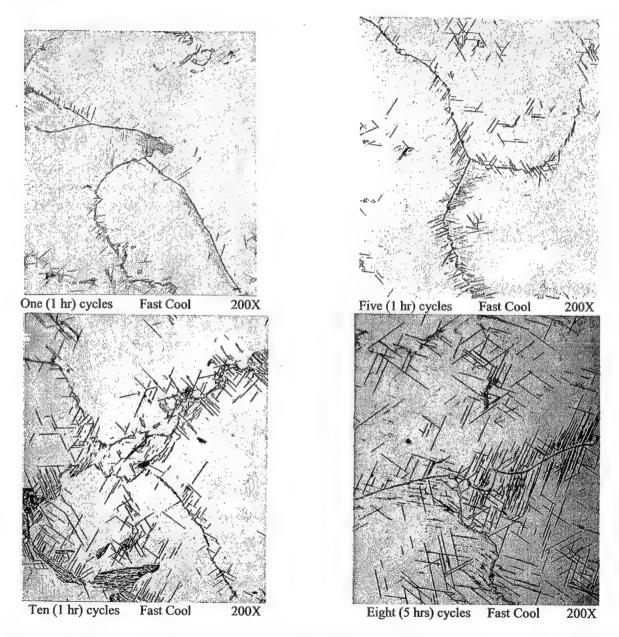
Results confirmed earlier studies regarding the reaction of the cast forms of Inconel 718 with additional exposures to the 1750°F solution temperature. Even where there was a high concentration of needle delta in the weld material, it was restricted to the interdendritic core and grain boundary areas. Most of the delta that precipitated in the cast+HIP material was mainly at the grain boundaries, but there was some intragranular precipitation, especially at the large MC carbides.

FIGURE B-4. TYPICAL MICROSTRUCTURE OF FULLY HEAT-TREATED PWA 1469 (CAST+HIP INCONEL 718) WITH 1 (UPPER LEFT), 5 (UPPER RIGHT), 10 (LOWER LEFT), AND 40 (LOWER RIGHT) HOURS AT THE 1750°F SOLUTION TEMPERATURE

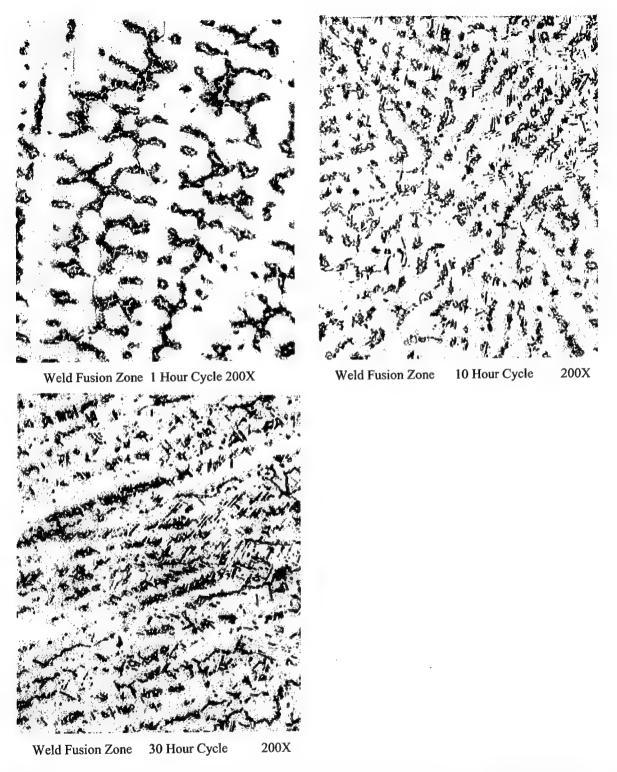
FIGURE B-5. TYPICAL MICROSTRUCTURE OF FULLY HEAT-TREATED INCONEL 718 WELD FUSION ZONE WITH 1 (UPPER LEFT), 10 (UPPER RIGHT), AND 30 (LOWER LEFT) HOURS AT THE 1750°F SOLUTION TEMPERATURE

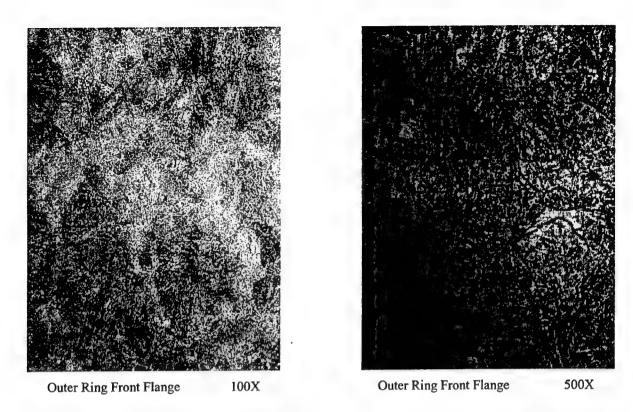
The coarser grain and sensitized microstructure of the outer ring is attributed to its size and the heat treat procedures used with the case. The outer ring is substantially thicker in cross section than the inner ring and sheet metal struts. It would be expected that this hot-rolled ring forging would display a relative coarse grain relative to the thin sheet details and smaller thinner inner ring. Multiple tempers may lead to a sensitized microstructure, but the other case details would also be affected. The more probable cause is that the case experienced a more than typical slower cool from solution than experienced with test material. Most test material, including that used in this program, is hardened by a liquid quench from the solution temperature. However, large structural assemblies such as the TECs cannot be liquid quenched because they would experience severe distortion. Typically the TECs are solution heat treated followed by a forced gas cool, which is not as fast as a liquid quench. The forced gas cool most probably produced the sensitized microstructure. Quantitative metallography was not performed on the case samples, but qualitatively, the outer ring forward areas appeared to be more sensitized than the other case areas. These areas are the hottest operating and the microstructure may reflect this fact. Delta ferrite and other stringers were observed but not to any great degree.

FIGURE C-1. GENERAL MICROSTRUCTURE OF JT9D TURBINE EXHAUST CASE OUTER FLANGE

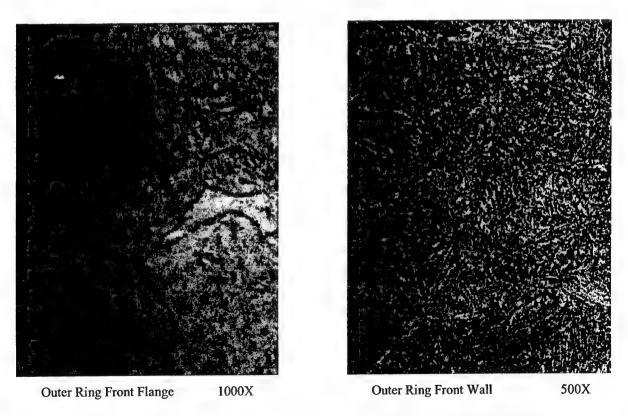
FIGURE C-2. GENERAL MICROSTRUCTURE OF JT9D TURBINE EXHAUST CASE OUTER RING FRONT FLANGE AND FRONT WALL

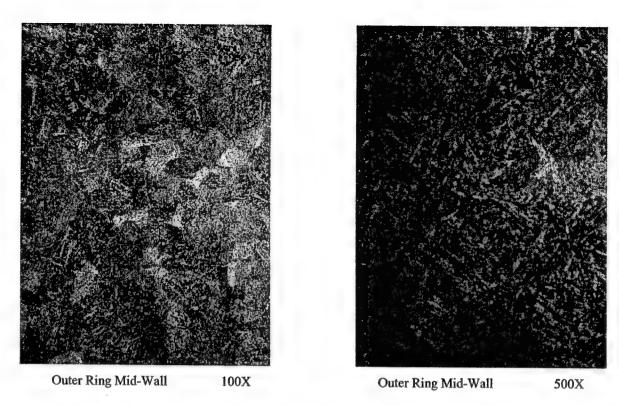
FIGURE C-3. GENERAL MICROSTRUCTURE OF JT9D TURBINE EXHAUST CASE OUTER RING MID-WALL

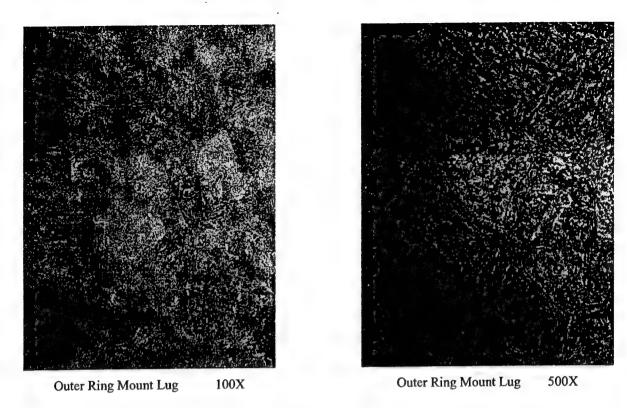
FIGURE C-5. GENERAL MICROSTRUCTURE OF JT9D TURBINE EXHAUST CASE OUTER RING MOUNT LUG

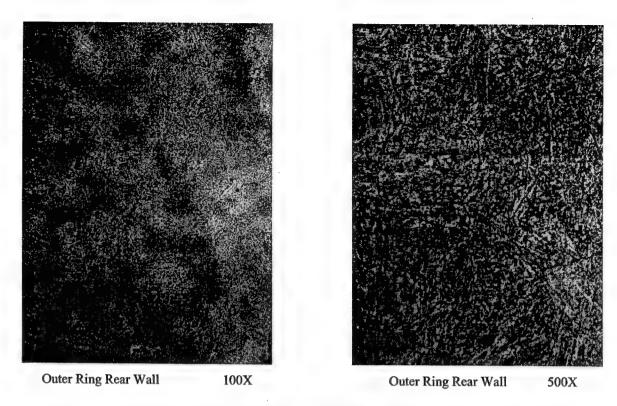
FIGURE C-7. GENERAL MICROSTRUCTURE OF JT9D TURBINE EXHAUST CASE OUTER RING REAR WALL

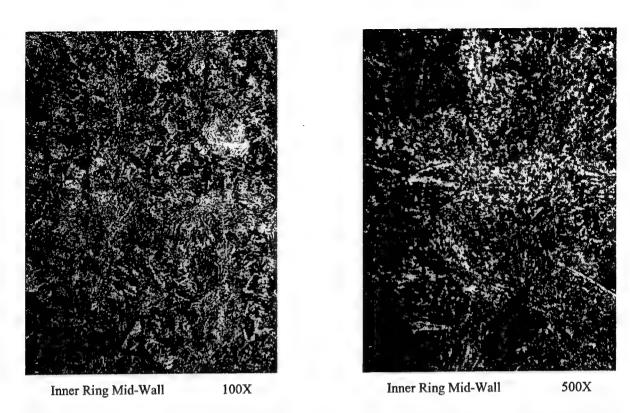
The inner ring and struts displayed typical martensitic structure with the strut sheet material (AMS 5596) having a measurably finer grain size than the inner ring. Strut-to-case attachment welds were even finer grained. Deep notches were discovered at the strut/case attachment welds within the hollow struts. It is not known if these were present at completion of construction of the case as a new assembly or occurred subsequent to initiation of commercial service. The microstructure of the outer ring displayed a more sensitized like microstructure with grain boundaries that are heavily decorated with carbides. The grain structure of the outer ring was also coarser than the inner ring. No significant difference in microstructure was observed among different areas of the same detail, suggesting that whatever differences in temperature exposure that may have existed during engine operation, they were sufficiently similar as to not create microstructural differences.

FIGURE C-9. GENERAL MICROSTRUCTURE OF JT9D TURBINE EXHAUST CASE INNER RING MID-WALL

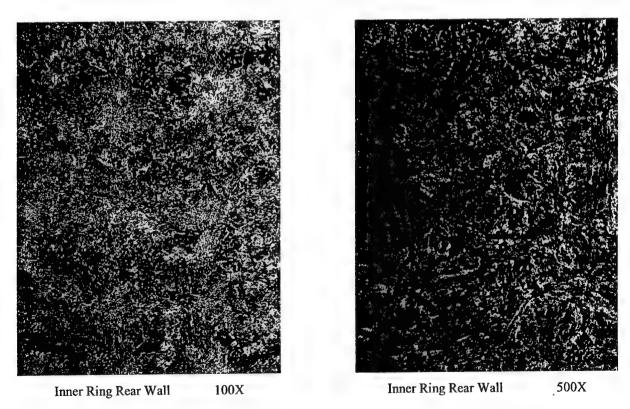
FIGURE C-10. GENERAL MICROSTRUCTURE OF JT9D TURBINE EXHAUST CASE OUTER RING REAR WALL

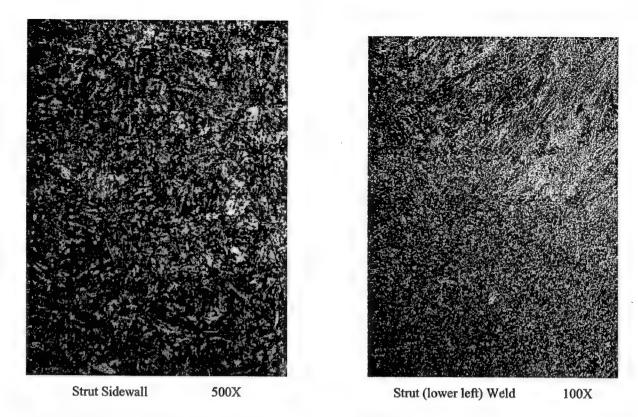
FIGURE C-11. GENERAL MICROSTRUCTURE OF JT9D TURBINE EXHAUST STRUT

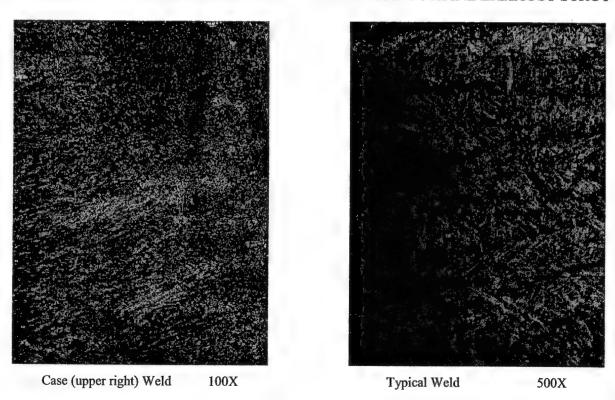
FIGURE C-12. GENERAL MICROSTRUCTURE OF JT9D TURBINE EXHAUST CASE WELD

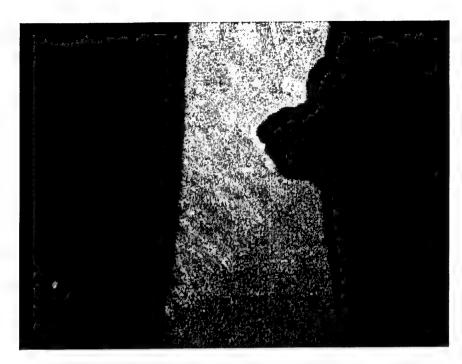
Strut (lower)/Case Weld

FIGURE C-13. GENERAL MICROSTRUCTURE OF JT9D TURBINE EXHAUST CASE LOWER STRUT/CASE WELD

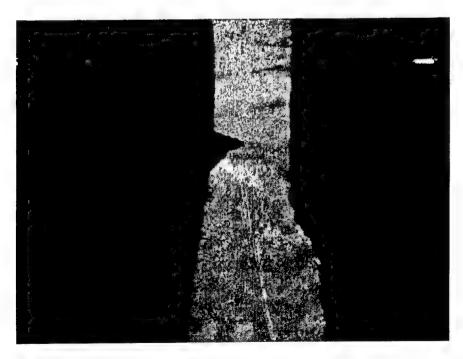
Strut (Upper)/Case Weld

FIGURE C-14. GENERAL MICROSTRUCTURE OF JT9D TURBINE EXHAUST CASE UPPER STRUT/CASE WELD

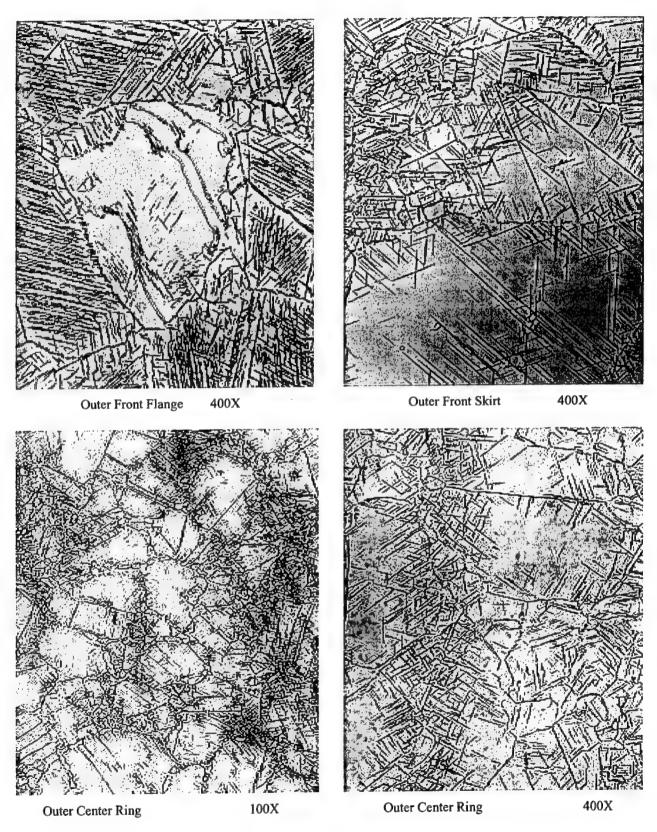
All three AMS 5663 details that comprise the outer pressure wall displayed significant banding. The general microstructure was of moderately coarse grains (ASTM 5 and 6) with areas where there was minimal needle delta structure interspersed with bands of high needle delta phase concentrations. Some areas displayed necklace structure, with coarse grains encircled with fine dynamically recrystallized grains. High magnification examination revealed that most grain boundaries were decorated with globular particles, both delta and carbides. Most surfaces displayed a denuded surface layer beneath which was another layer of concentrated needle delta. The denuded layer varied in depth from 0.0006" to 0.0009", while the layer of concentrated needle delta varied in depth from 0.005" to 0.0075".

FIGURE D-2. JT9D DIFFUSER S/N AG9961, GENERAL MICROSTRUCTURES OF OUTER PRESSURE WALL DETAILS

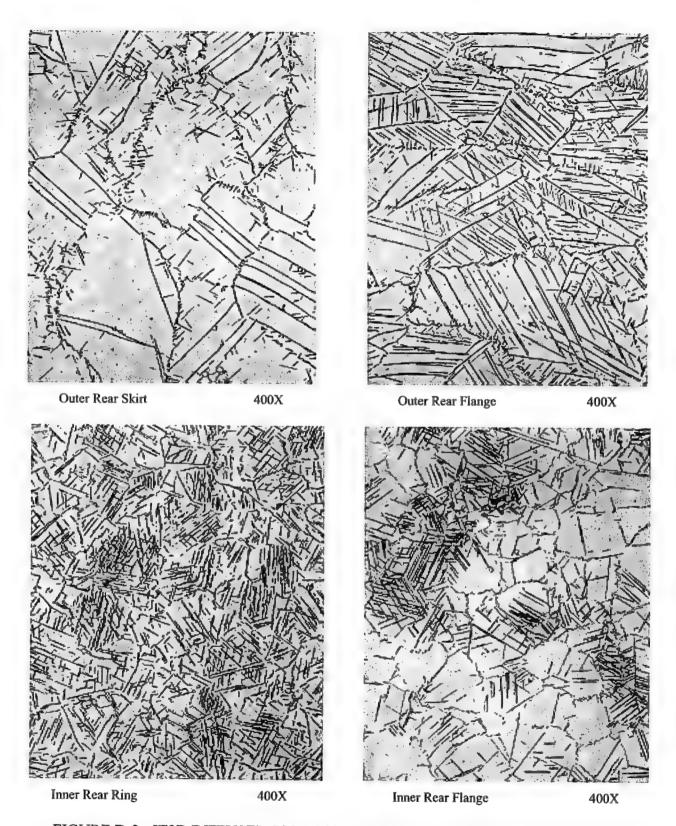
Inner pressure wall AMS 5663 details had a similar banded delta structure, surface denuded layer, and concentrated delta layer. Here the denuded layer depth varied from 0.0004" to 0.0005", and the delta layer varied in depth from 0.0044" to 0.006". The rear ring, which is a rolled sheet of AMS 5596, displayed a finer grain structure (ASTM 8) with lighter banding but an overall high concentration of needle delta throughout the microstructure. The separate attached rear flange was coarse (ASTM 3-4) with less overall needle delta but with concentrations of delta in blotches rather than more continuous bands.

FIGURE D-3. JT9D DIFFUSER S/N AG9961, GENERAL MICROSTRUCTURES OF OUTER REAR (UPPER) AND INNER REAR (LOWER) RING DETAILS

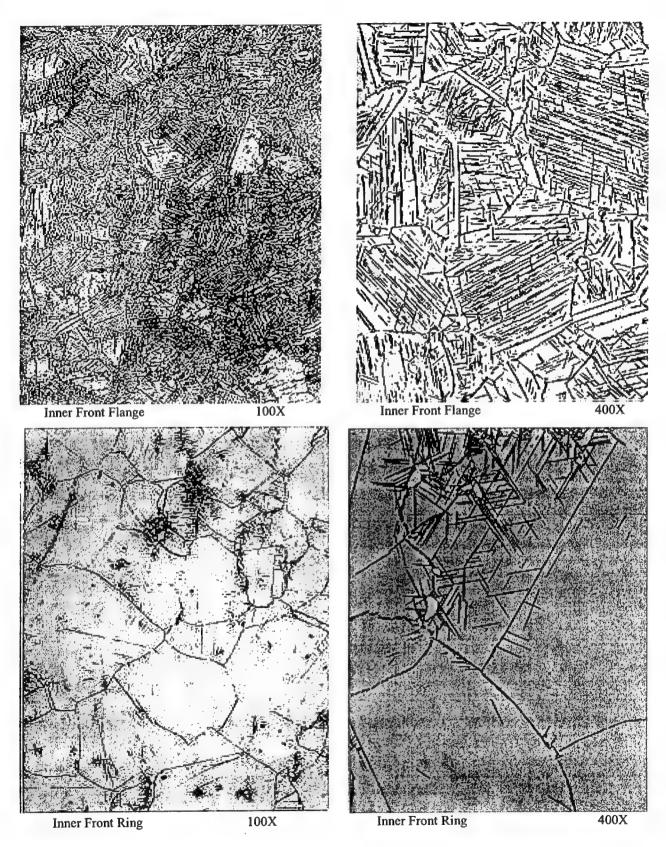
FIGURE D-4. JT9D DIFFUSER S/N AG9961, GENERAL MICROSTRUCTURES OF THE INNER FRONT RING DETAIL

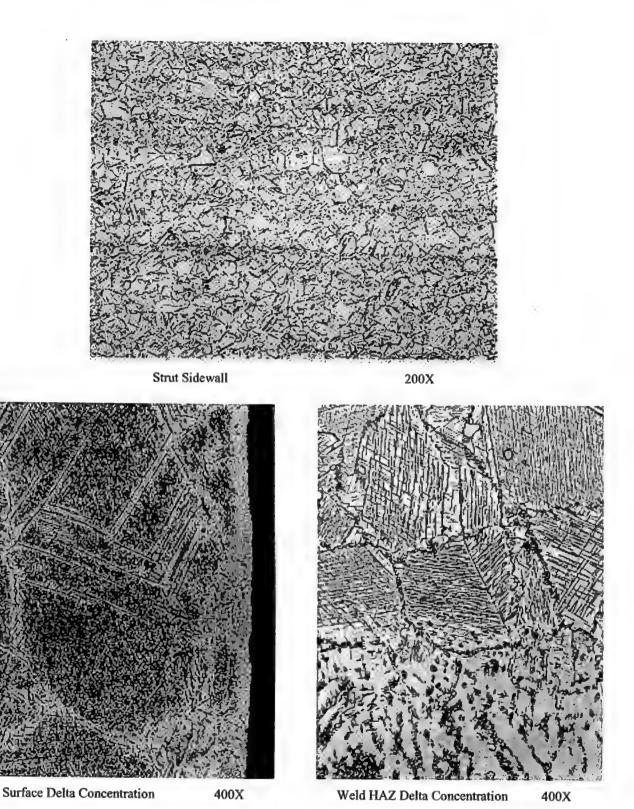
FIGURE D-5. JT9D DIFFUSER S/N AG9961, GENERAL MICROSTRUCTURES OF THE STRUT (UPPER) SHEET MATERIAL AND HEAVY CONCENTRATIONS OF NEEDLE DELTA PHASE ASSOCIATED WITH SOME SURFACES (LOWER LEFT) AND WELD HAZ (LOWER RIGHT)

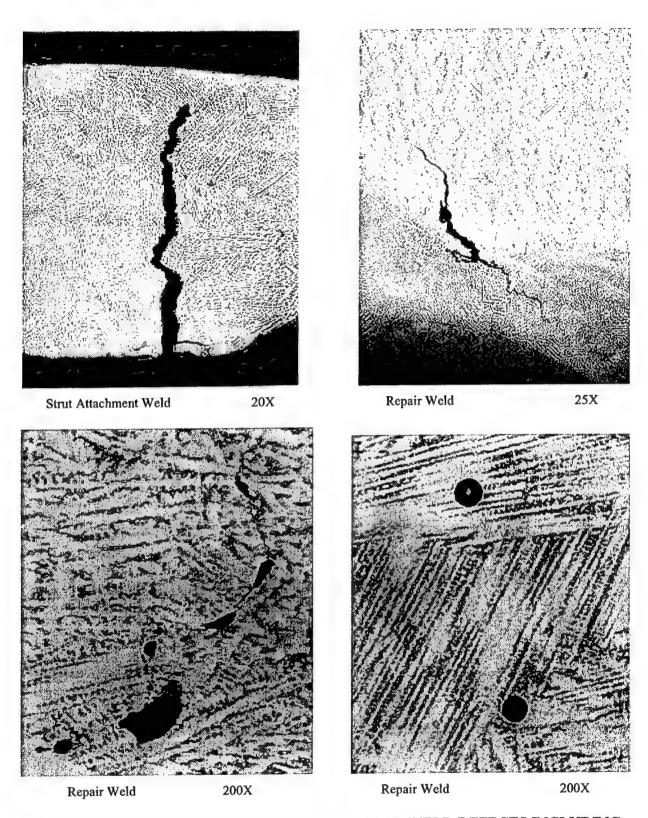
FIGURE D-6. JT9D DIFFUSER S/N AG9961, TYPICAL WELD DEFECTS INCLUDING CRACKS (UPPER), LACK OF FUSION (LOWER LEFT), AND GAS PORES (LOWER RIGHT)

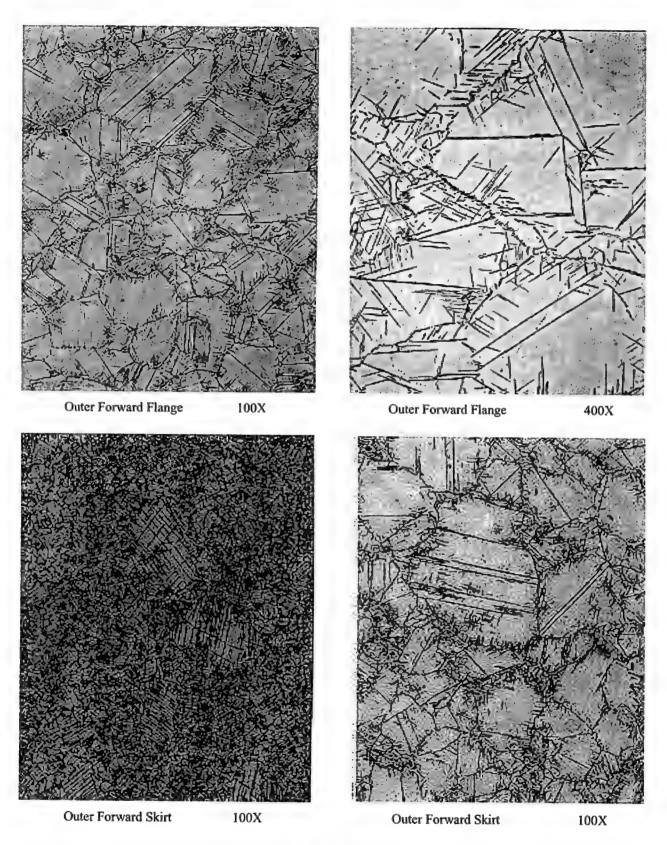
0.0150". The deepest denuded layers and delta plate layers were on the forward skirt. Concentrations of delta needles were also found associated with the threads on the tapped boltholes located on the inner surface of the forward skirt.

FIGURE D-7. JT9D DIFFUSER S/N BW0976, GENERAL MICROSTRUCTURES OF THE OUTER FRONT SKIRT DETAIL

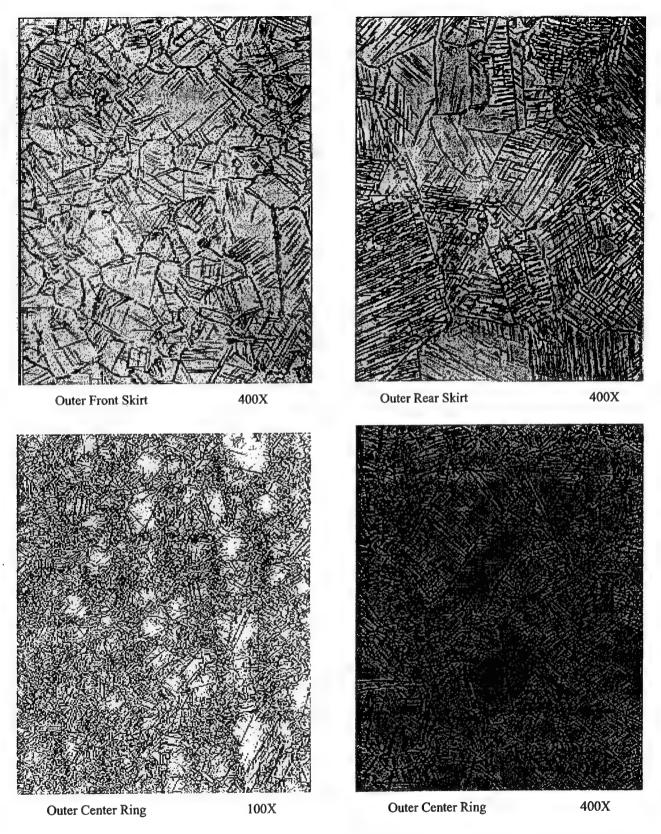
FIGURE D-8. JT9D DIFFUSER S/N BW0976, GENERAL MICROSTRUCTURES OF THE OUTER FRONT SKIRT (UPPER LEFT), OUTER REAR SKIRT (UPPER RIGHT), AND OUTER CENTER RING DETAILS

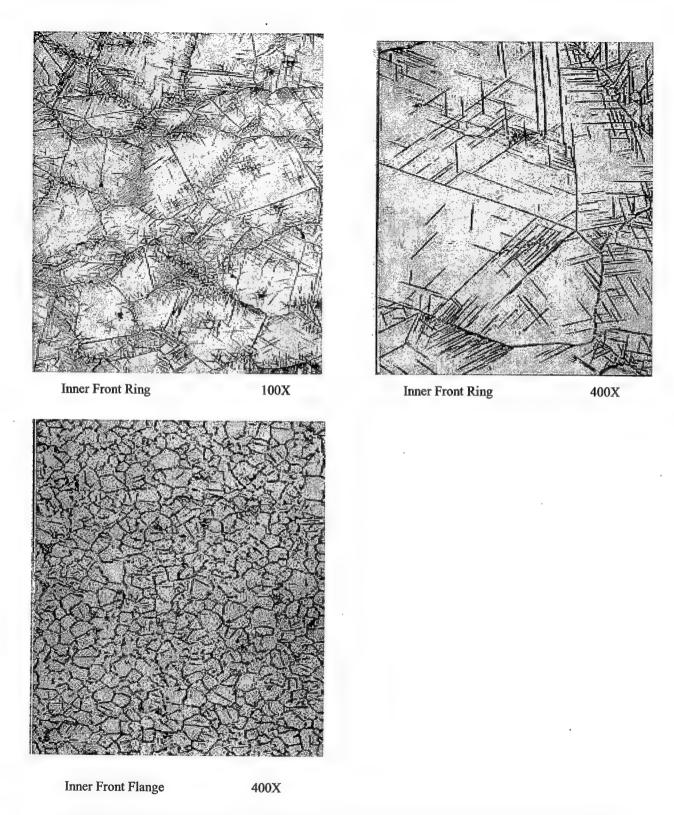
The inner cylinder of case BW0976 presented a myriad of microstructures. The forward flange was a very fine grain (ASTM 10-11) forging that obviously was a replacement for the original integral flange. Microstructure for this piece consisted of globular delta in the grain boundaries and no needle-shaped delta phase. The forward ring was moderately coarse-grained (ASTM 4-6) consisting of generally equiaxed grains with heavy grain boundary needle delta precipitation. Patches of very heavy delta concentrations were observed throughout the material. The rear cylinder (AMS 5596 sheet) was fine grain (ASTM 8-9) with extensive amounts of delta plates scattered somewhat evenly among the microstructure. The separate rear flange was another fine grain (ASTM 11-12) forging with scattered globular delta and no needle delta phase. The heat shield was moderately coarse grain (ASTM 5) while the supporting bracket was much finer (ASTM 6). Both the heat shield and bracket had extensive needle delta phase distributed evenly throughout the microstructure. Surface denuded layers as deep as 0.0009" and surface layers of concentrated needle delta were detected as deep as 0.013". The heat shield also had a shallow oxide layer (0.00015") with oxide spikes or cracks extending into the denuded surface layer. Neither of the very fine-grained flanges displayed any evidence of concentrated needle delta on their respective surfaces but did display a denuded surface layer.

FIGURE D-9. JT9D DIFFUSER S/N BW0976, GENERAL MICROSTRUCTURES OF THE INNER FRONT RING DETAIL (The much finer grain microstructure of the flange (lower) relative to the detail ring wall (upper) illustrates that this front flange is a repair replacement flange attached sometime in the service life of the case.)

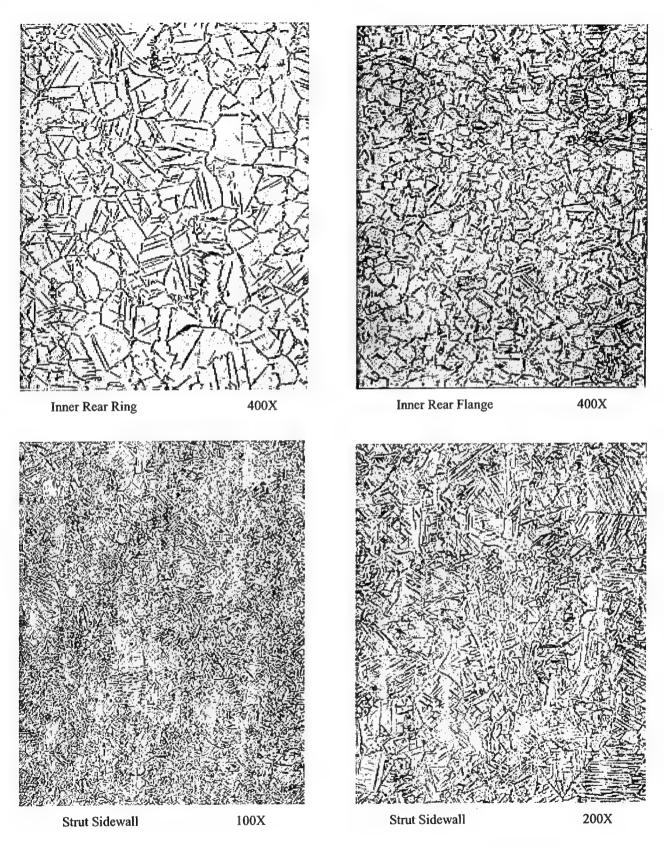
Grain size of the sheet material used to construct the struts was moderate fine grain (ASTM 6-7) but like the other sheet metal details displayed extensive amounts of needle delta phase scattered evenly throughout the microstructure.

FIGURE D-10. JT9D DIFFUSER S/N BW0976, GENERAL MICROSTRUCTURES OF THE INNER REAR RING (UPPER) AND STRUT (LOWER) DETAILS

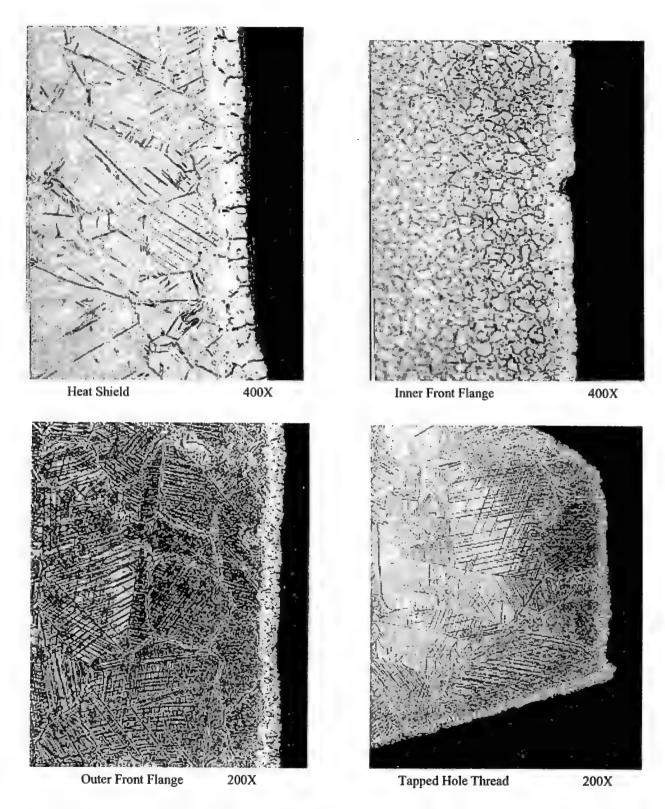
FIGURE D-11. JT9D DIFFUSER S/N BW0976, EXAMPLES OF SURFACE DEPLETION ON INNER CASE DETAILS (UPPER) AND CONCENTRATED NEEDLE DELTA ASSOCIATED WITH SOME SURFACES (LOWER LEFT) AND THREADS (LOWER RIGHT)

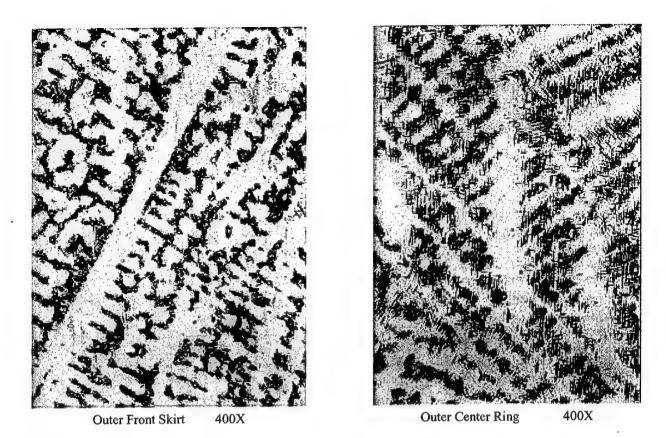
Assembly and repair welds on the outer pressure wall were generally sound but several contained large pools of laves phase. Often the adjacent base metal also contained very high concentrations of needle delta phase. Numerous cracks were observed emanating outward from the bracket to heat shield resistance weld and within the fusion zone of the heat shield/bracket assembly weld.

FIGURE D-12. JT9D DIFFUSER S/N BW0976, REPAIR WELD MICROSTRUCTURES (The higher (slightly) concentration of needle delta in the weld located on the center ring (left) relative to the front skirt repair (left) suggests that the center ring repair was exposed to more re-solution heat treatments over the service life of the case.)

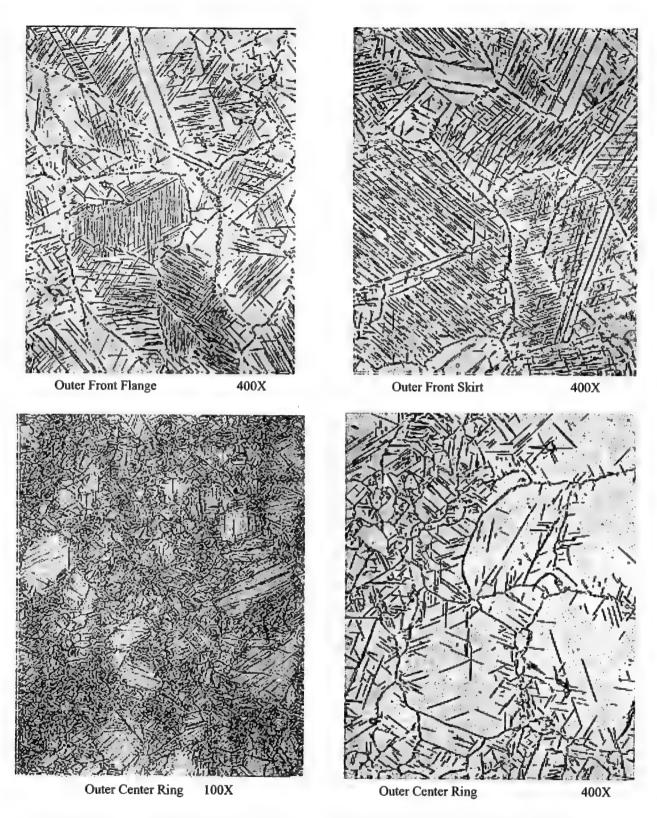
Within the outer pressure wall, heavy concentrations of needle-shaped delta phase were present throughout the forward skirt (and flange) and in patches and at grain boundaries of the center ring and rear skirt details. The rear skirt displayed the least of the patches but in the thicker sections of the skirt concentrations of needle delta could be extensive. The amount of evenly distributed delta phase in the forward and center rings made it difficult to ascertain if a surface layer of high delta phase concentration existed. However, a surface denuded layer of 0.00078" was observed on the forward skirt regions of the case. Heavy concentrations of delta needles were also observed associated with the tapped lugs on the forward skirt.

FIGURE D-13. JT9D DIFFUSER S/N CJ3225, GENERAL MICROSTRUCTURES OF THE OUTER FRONT SKIRT (UPPER) AND OUTER CENTER RING (LOWER) DETAILS

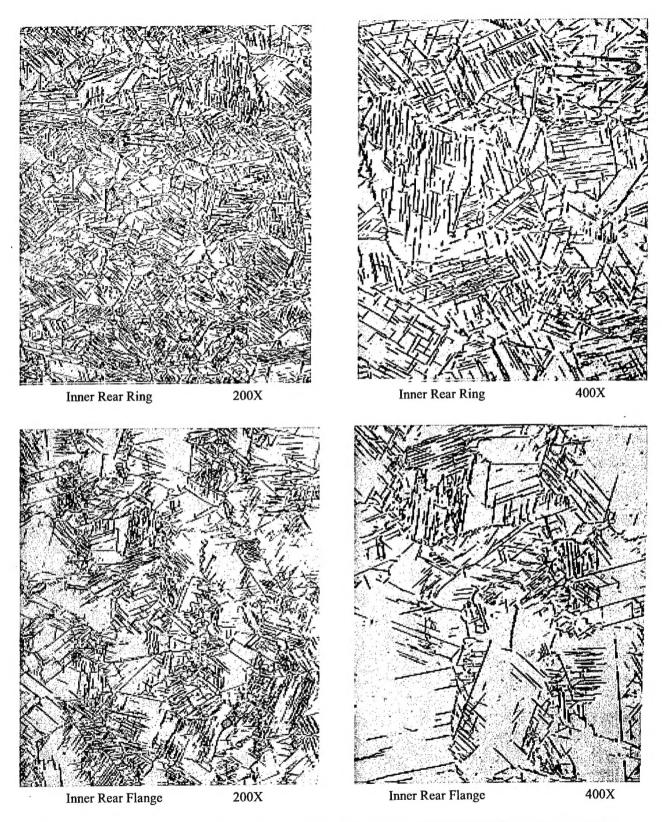
FIGURE D-16. JT9D DIFFUSER S/N CJ3225, GENERAL MICROSTRUCTURES OF THE INNER REAR RING DETAILS

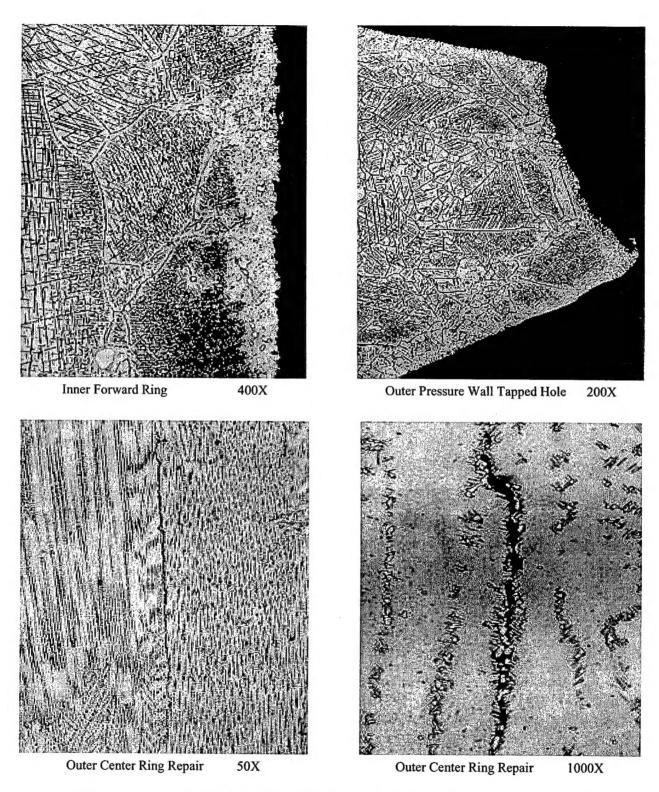
FIGURE D-17. JT9D DIFFUSER S/N CJ3225, HEAVY CONCENTRATIONS OF NEEDLE DELTA ASSOCIATED WITH SOME SURFACES (UPPER LEFT) AND TAPPED HOLE THREADS (UPPER RIGHT) AND REPAIR WELD CRACKS (LOWER) (The crack illustrated in the lower right figure is associated with interdendritic concentrations of laves phase.)
